TECHNICAL SOLUTIONS FOR THE IMPROVEMENT OF LEVELISED COST OF WIND ENERGY OFFSHORE

ANNUAL EVENT
2024
BILBAO
20-22 MARCH

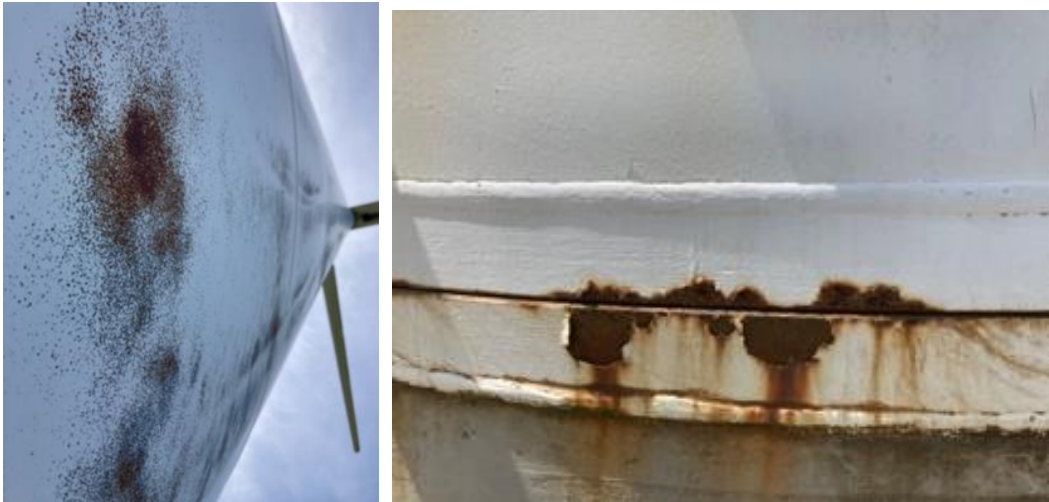
Corrosion and fatigue are the main mechanisms of deterioration in offshore structures affected by severe environmental factors such as extended periods of wetness, UV-radiation, abrasion and erosion, which eventually accelerate corrosion rates.

Figure 1 Corrosion on tubular tower and on flanges.

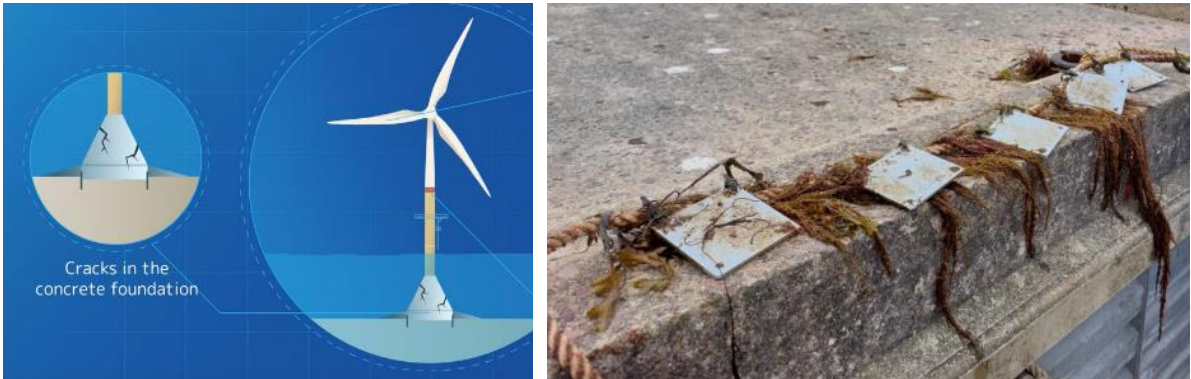
Figure 2 Crack issues on concrete structures and biofouling issues.

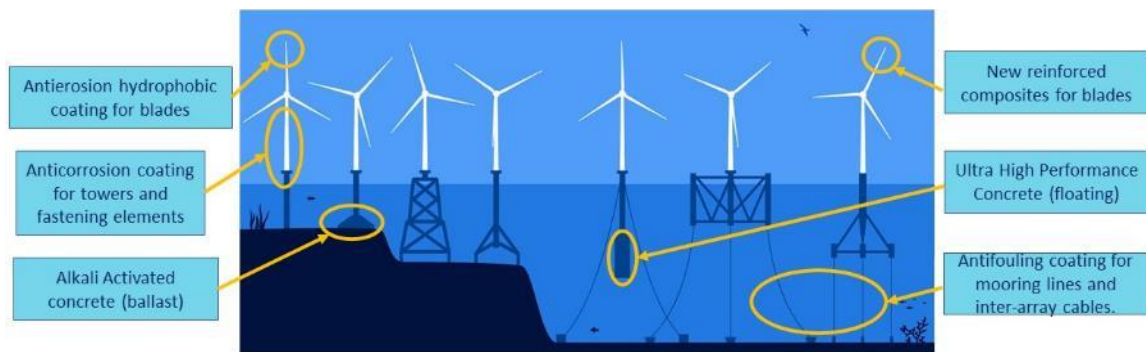
The main action points related to material development focus on coatings, concrete and composites.

Figure 3 Main action points related to material development within MAREWIND project.

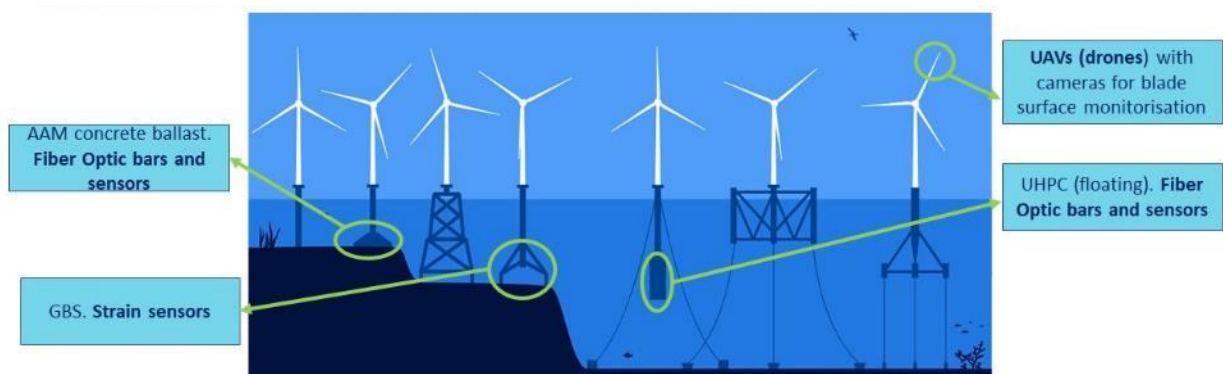
On the other hand, the control of material status and evolution for preventive measures and a more accurate maintenance, is developed by Structural Health Monitoring tools, including fiber optic bars, strain sensors, Unmanned Aerial Vehicles (UAVs) and advanced thermographic cameras among others.

Figure 4 Main action points related to Structural Health Monitoring within MAREWIND project.

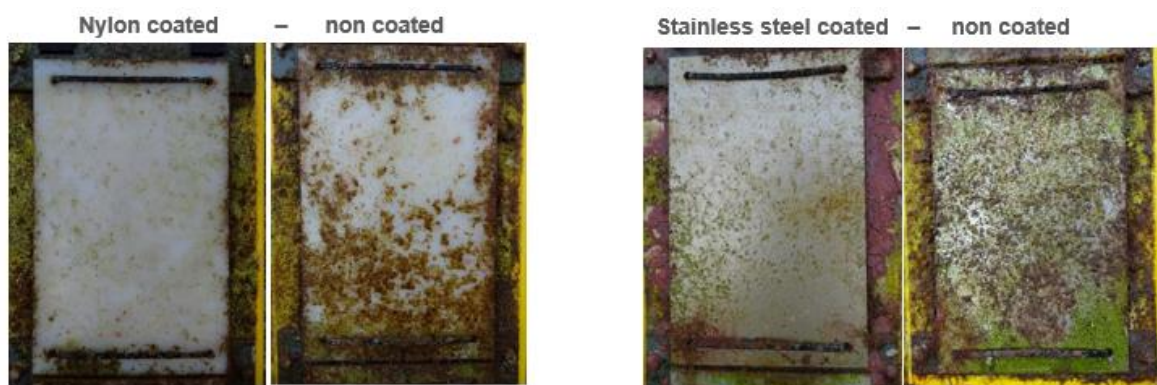
Antifouling coated samples show significant delay in fouling cumulation. These results have been partially obtained at PLOCAN-Canarias after obtaining access for 2022-2023.

Figure 5 Relevant results related to antifouling coating, showing delay in accumulation in both polymer (PA) and metal (Stainless steel), after exposure according to ASTM D 3623 standard.

- **Antifouling coating:** significant delay in fouling cumulation after several months immersed in the sea. This can reduce the maintenance needs and reduce associated costs.

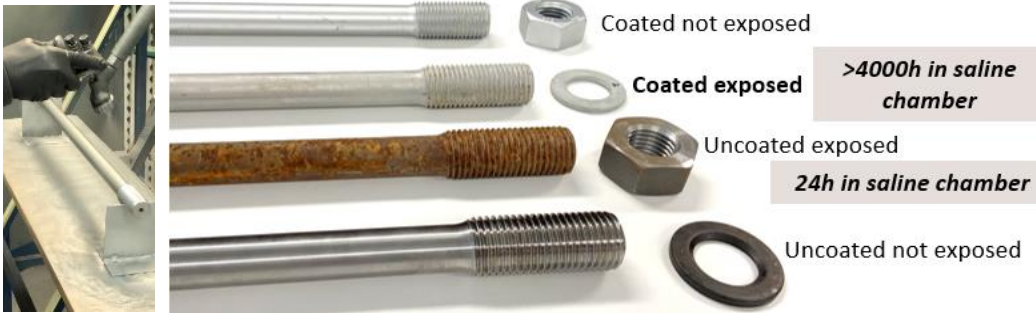
Anticorrosion coating has been validated with no corrosion damage for more than 4200 hours in cycling tests exposure (1800h UV, 600h freezing and 1800h saline mist chamber) based on ISO12944-9. Apart from panels, real carbon steel fastening elements, such as bolts, washers and nuts, were also protected for more than 4000 hours in saline mist chamber.

Figure 7 Direct application by spray gun of the anticorrosion coating as well as relevant results obtained after long-range exposure to saline mist chamber on real fastening elements from TSF.

- **Anticorrosion coating:** the resistance achieved in the laboratory testing would correspond to CX corrosivity category, implying extreme resistance of more than 25 years. Easy and direct application of the coating by spray gun has been demonstrated and the production of 100 L validated its upscaling. An alternative of lower thickness and reduced weight is proposed for easier implementation and reduced investment for application, while keeping the protection.

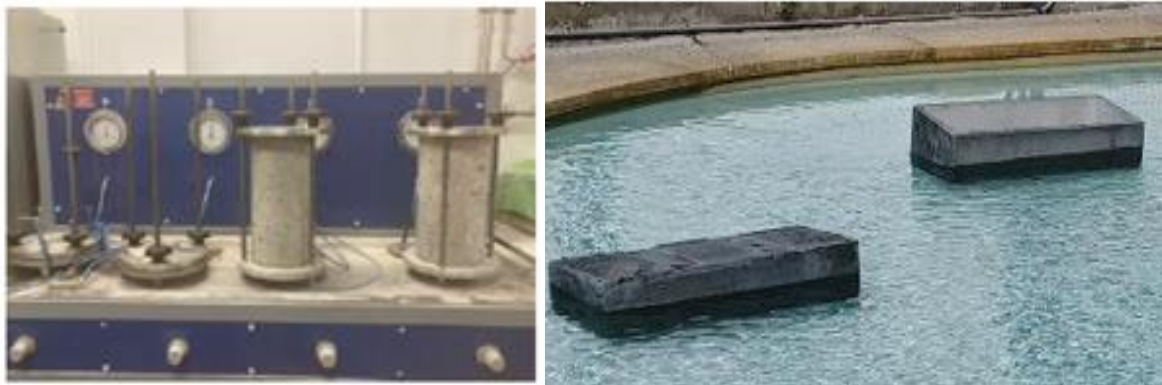
Ultra-High Performance Concrete (UHPC) developed by ACCIONA presents 33% reduction in cement used compared to standard. Durability tests according to NT-492 showed after a year of exposure negligible corrosion rate ($k\Omega \cdot cm$) and extremely high chloride penetration resistance ($0.008 m^2/s$). Freeze and thaw resistance test reflected high durability performance at 200 cycles.

Figure 9 Small prototypes performed in preliminary trials to check production process and buoyancy.

- **UHPC developed** presents a more sustainable solution than standard UHPC and shows 90% durability improvement compared to a standard C60 at same age. The complex maintenance of concrete structures would be drastically reduced.

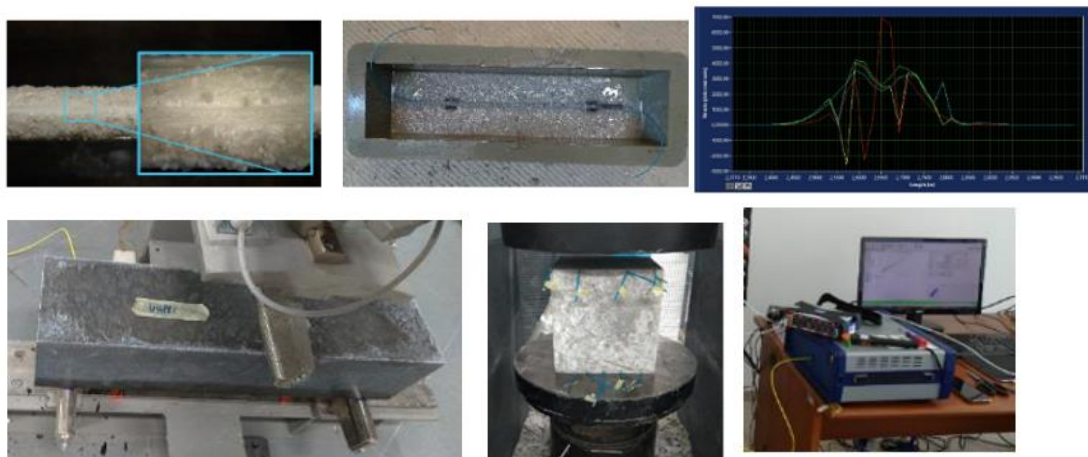
Regarding Structural Health Monitoring activities, on the one hand, integrated sensors have been successfully lab-scale demonstrated in concrete and blades.

Figure 10 Acquired signal from SHM system inside UHPC concrete beam in different instants of loads.

- Successful testing of sensors on both concrete (ballast, foundations) and on composite-based blades for **SHM**.

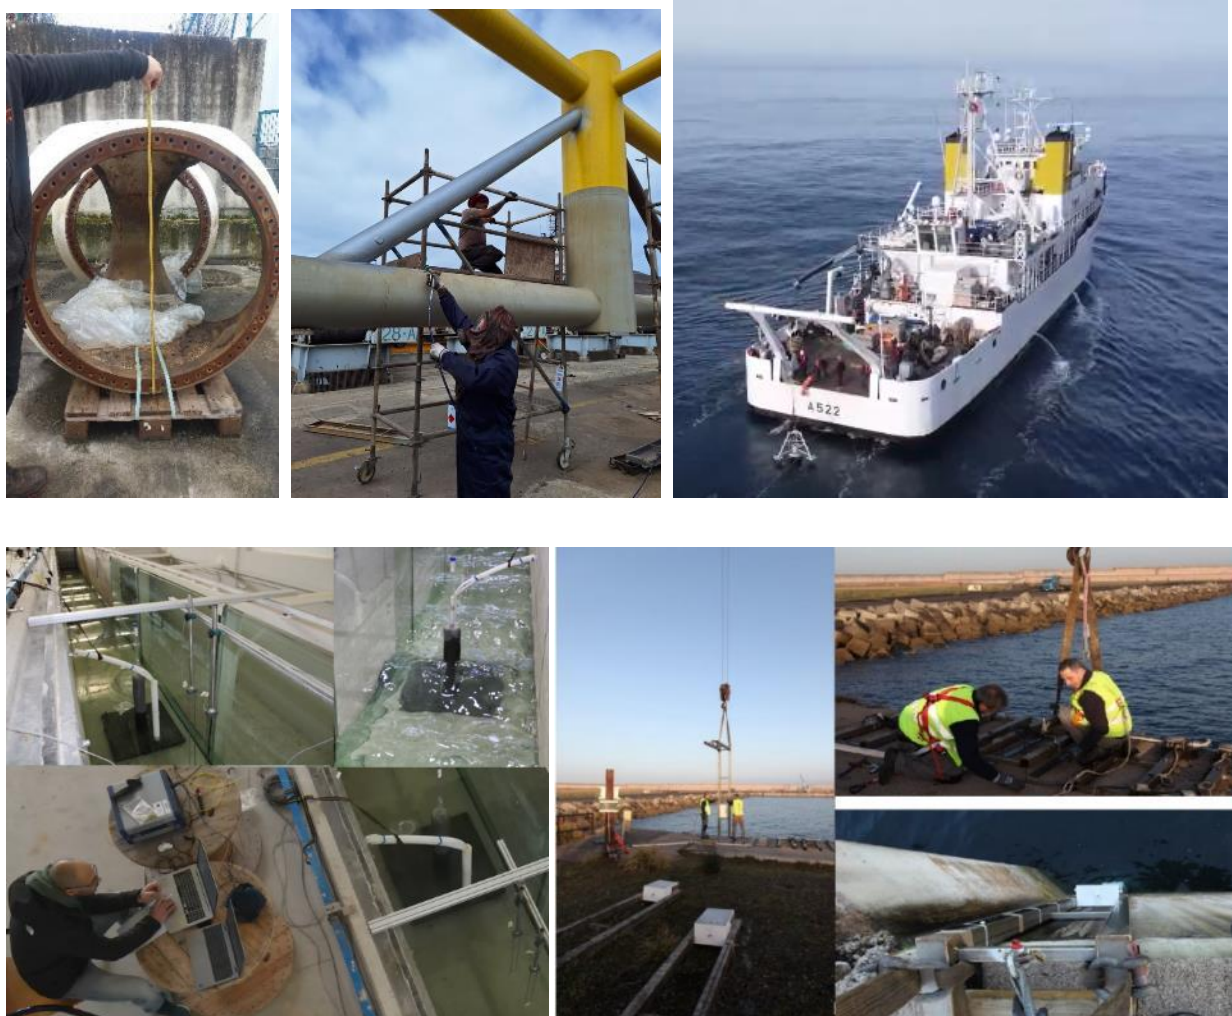
- Repair and maintenance activities on site for corrosion of metallic parts, leaded by KOSHKIL.
- Application of anticorrosion and antifouling coatings on Wind2Power floating platform from ENEROCEAN.
- Construction and deployment of a GBS structure immersed in the Sea by INEGI, including strain sensors, modified concrete ballast (AAM from CETMA) and antifouling coupons for real exposure testing.
- Wave channels tests started at EUMER with optimised concretes (UHPC and AAM) including fiber optic sensors for monitoring.
- UHPC prototypes have been installed by ACCIONA at Gijón Harbour for corrosion test performance at real environment.

Figure 12 Pictures of different demonstrative activities ongoing in the last year of MAREWIND project
