PO.241

MAREWIND MAterials solutions for cost Reduction and Extended service life on WIND off-shore facilities

Cristina Salazar Castro, Claudio Fernandez Acevedo, Marta Mateo García de Galdiano

L'Urederra Technological Centre

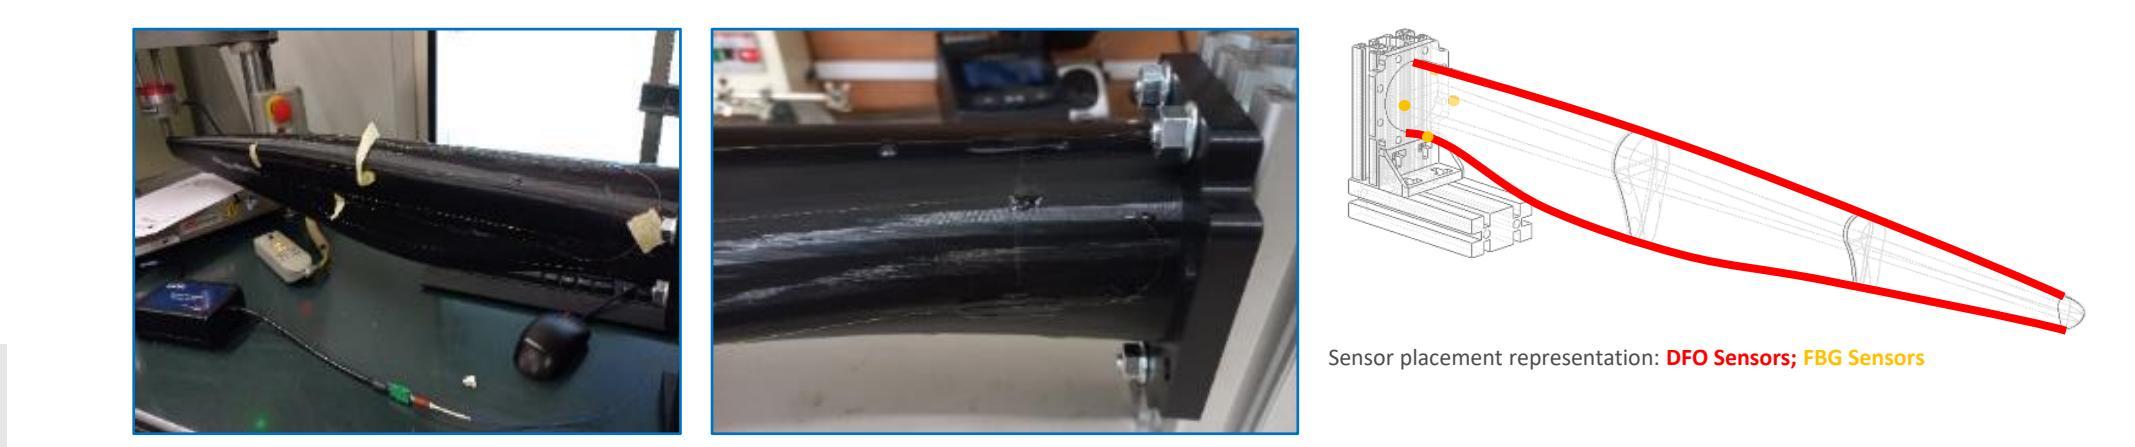
integrated sensors based on fiber optic have been successfully implemented for Structural Health Monitoring (SHM) in novel

concrete formulations and blades.

- Successful testing of sensors on concrete and composites for blades for SHM.
